# Manhole Inspection Summary

Manhole # S19II1007MH

**Location** Address: **I-83**

Cross Street: **41ST ST**

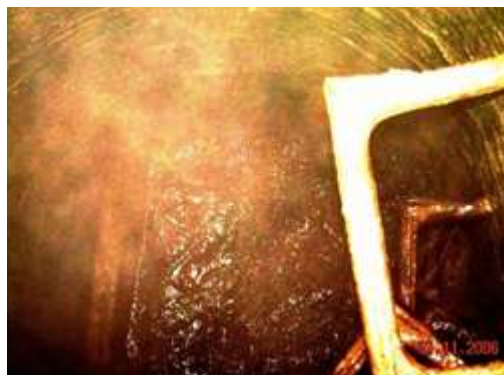
Top View

**Surcharge** ☒ **Evidence Of Surcharge** Depth: **5** (ft.) ☐ Active Surcharge Present

Evidence of surcharge - Bench debris.

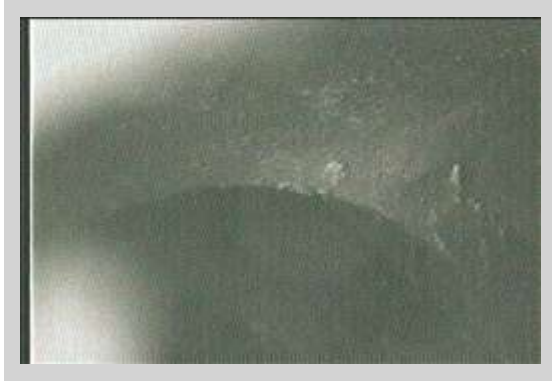
### 48 in. Circular Gravity Sewer Pipe Out @ 12 O'Clock

Pipe Material: **Concrete** ☐ Pipe Lined

Invert Depth: **19.90** (ft.) Flow Characteristics: **Fast**

Deposits: ☒ None ☐ Mud ☐ Sludge ☐ Debris ☐ Grease

Infiltration: **None** Pipe Seal Cond: **Unknown**

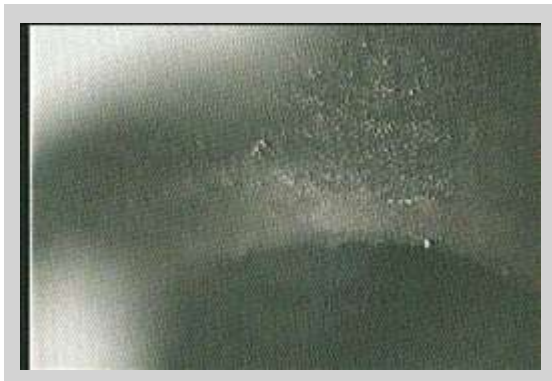
### 48 in. Circular Gravity Sewer Pipe In @ 6 O'Clock

Pipe Material: **Concrete** ☐ Pipe Lined

Invert Depth: **19.80** (ft.) Flow Characteristics: **Fast**

Deposits: ☒ None ☐ Mud ☐ Sludge ☐ Debris ☐ Grease

Infiltration: **None** Pipe Seal Cond: **Unknown**
